## Santa Fe County Public Works Boiler and Evaporative Cooler

### Site Visit and HydroFlow Application Evaluation

September 1, 2011

### Follow-up Evaluation May 18, 2012

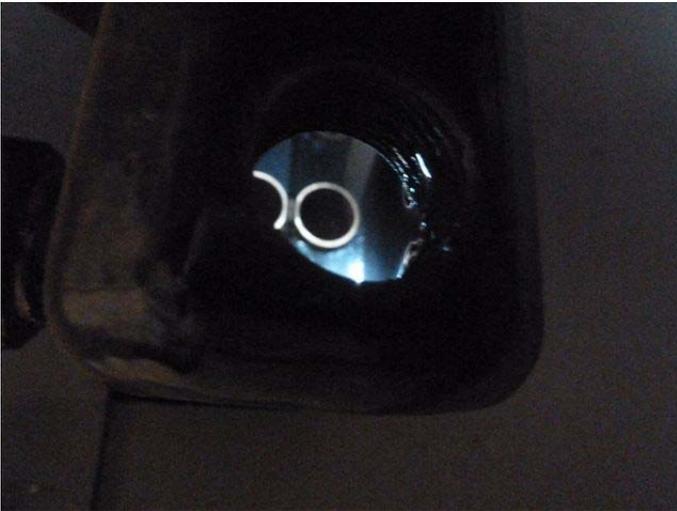
Heat exchanger tub viewed through inspection port. Absolutely NO SCALING was observed

We had a site visit on Tuesday at the Santa Fe County Public Works complex out on hwy 599. As a result of the significant hardness of the water from their on site well, they have had to rebuild their primary boiler twice since the building opened two years ago. To help them deal with this problem, we installed a HydroFlow S120 on the boiler to deal with their water hardness issues. On Tuesday morning they opened the boiler for inspection to evaluate the effectiveness of the S120 in dealing with their problem. We were delighted to find the boiler absolutely "scale free".

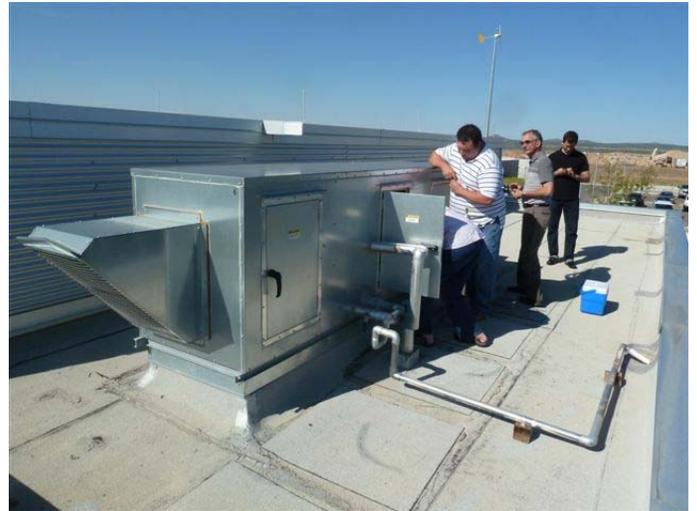
One of 22 evaporative coolers serving the complex

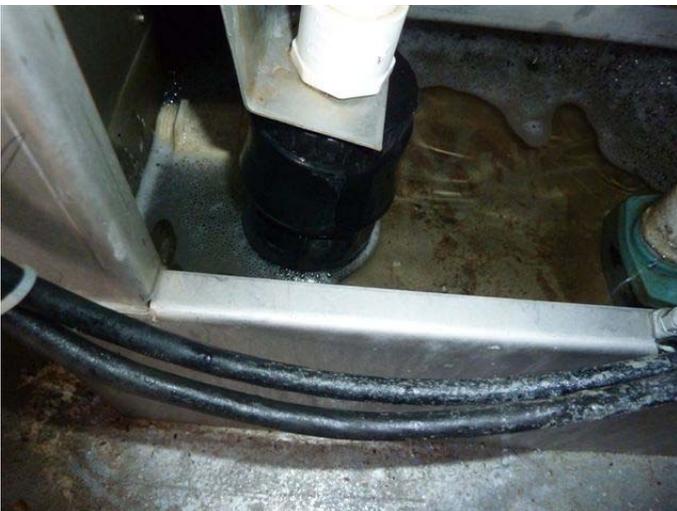
Evaporative cooler floats observed after a full season of operation. NO SCALE present

- Over this summer season, NO limescale has built up on the floats.
- The pumps were completely encrusted with limescale from the previous season. ALL limescale had dissolved from the submerged portion of the pumps and they were scale free.
- Maintenance requirements were reduced to virtually nothing.
- The units were operated at full air flow without water being blown off the pad as experienced in the previous year.
- It was calculated by the County that the water savings over this summer has resulted in more that 2,000,000 gallons saved.

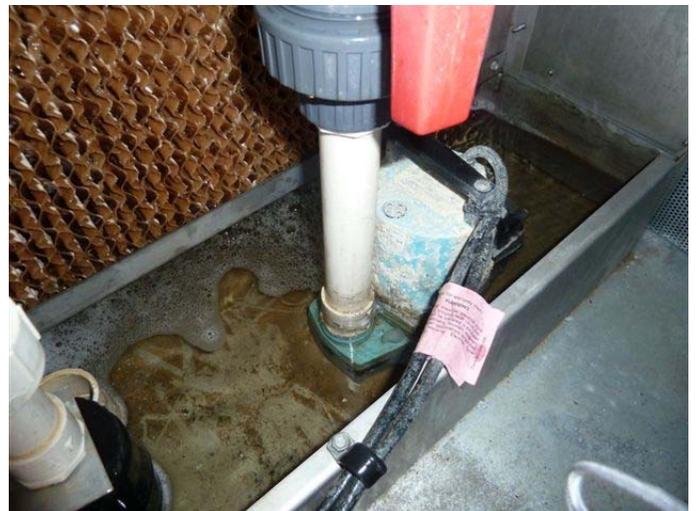
Pump and evaporative pad. Scale on the pump is from the previous season. Observe ALL SCALE below the water line is gone. Also observe pad is clear of scale build-up.

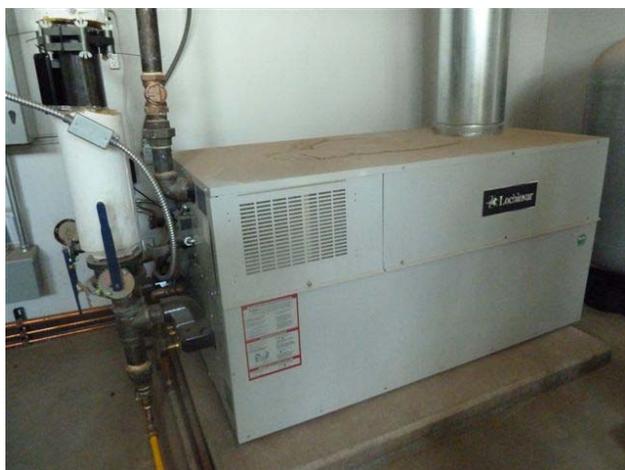
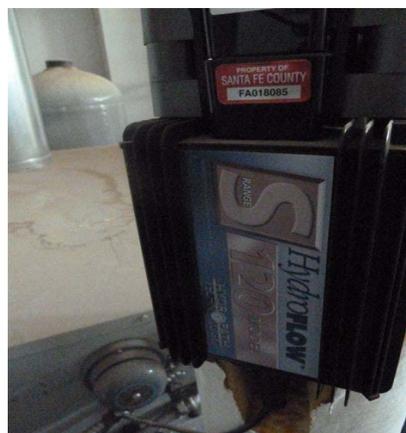
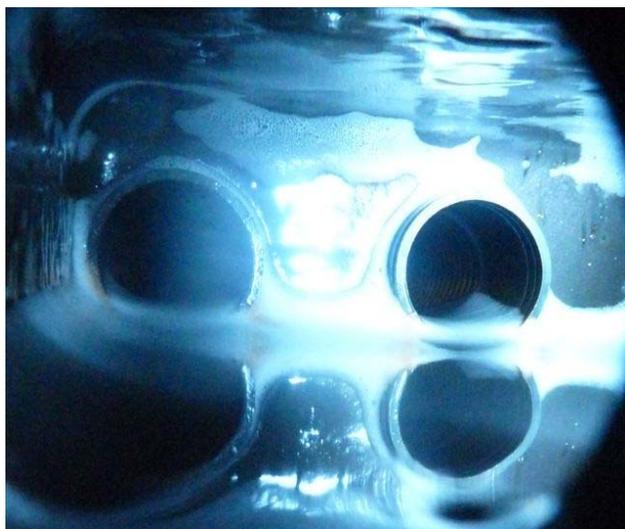
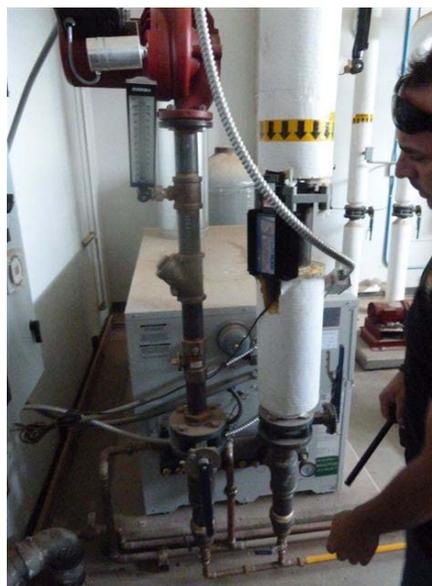
On May 18, 2012 we revisited the application to evaluate the boiler after a full heating season. Chris Anaya, their Mechanical HVAC Technician removed two of the inspection plugs so we could inspect the heat tubes of the heat exchanger. On looking into the heat exchanger, Chris's first words were "Wow". The boiler tubes looked absolutely new as can be seen by the following picture.
