On December 20, 2013 I installed a HydroFLOW S38 water treatment unit on a steam generator at the Santa Fe Indian Hospital. This unit was installed to evaluate the effectiveness of HydroFLOW in preventing and reversing scale accumulation in the boiler and on the heating elements. This was a trial being observed by the Indian Health Services of New Mexico to qualify HydroFLOW for further consideration for use on the boilers, cooling towers and other equipment at their facilities throughout New Mexico

Installation Details

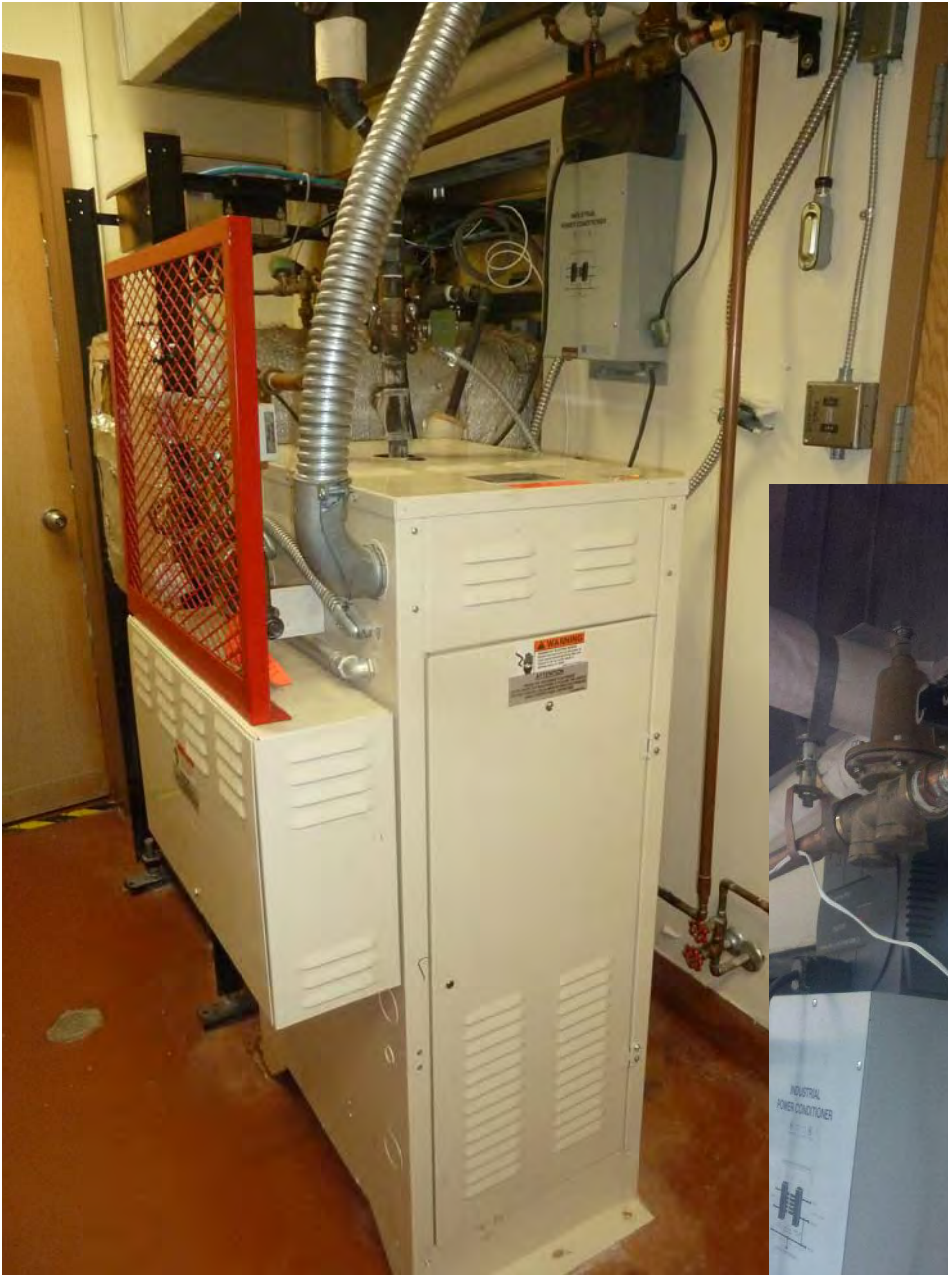
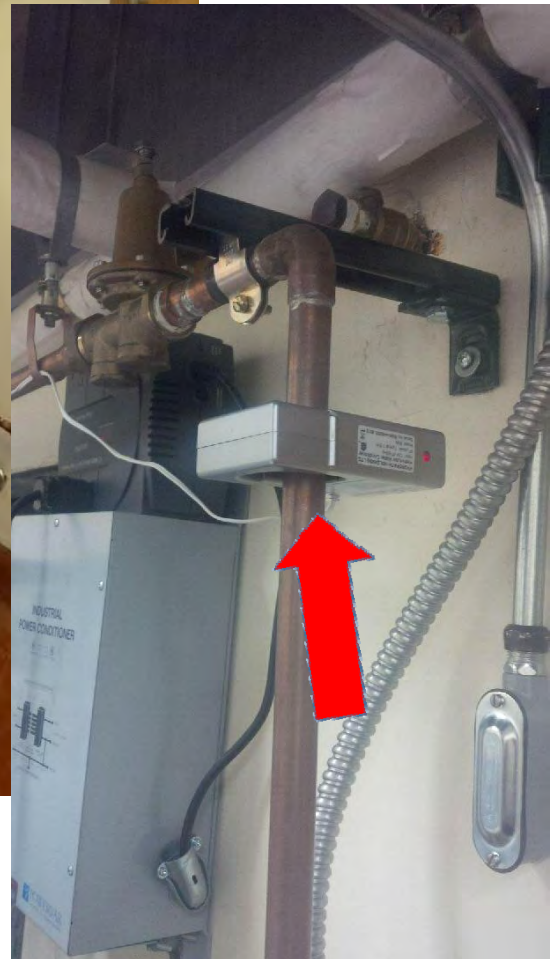
Installation Point for HydroFLOW S38 Unit

The S38 *HydroFLOW* water conditioner includes a surge protector and plugs into a standard 115 VAC outlet

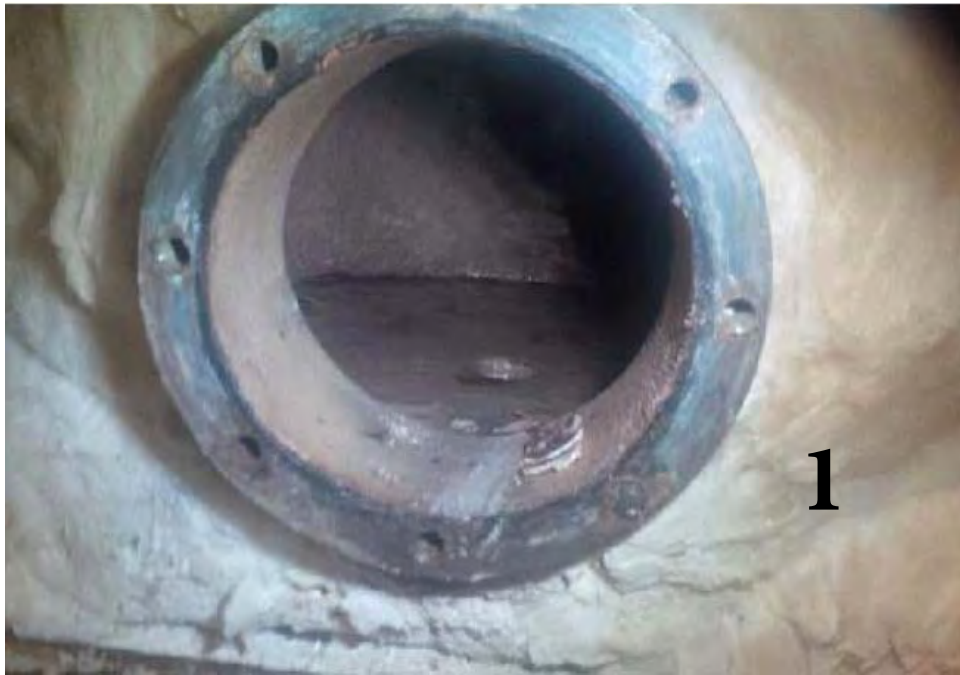
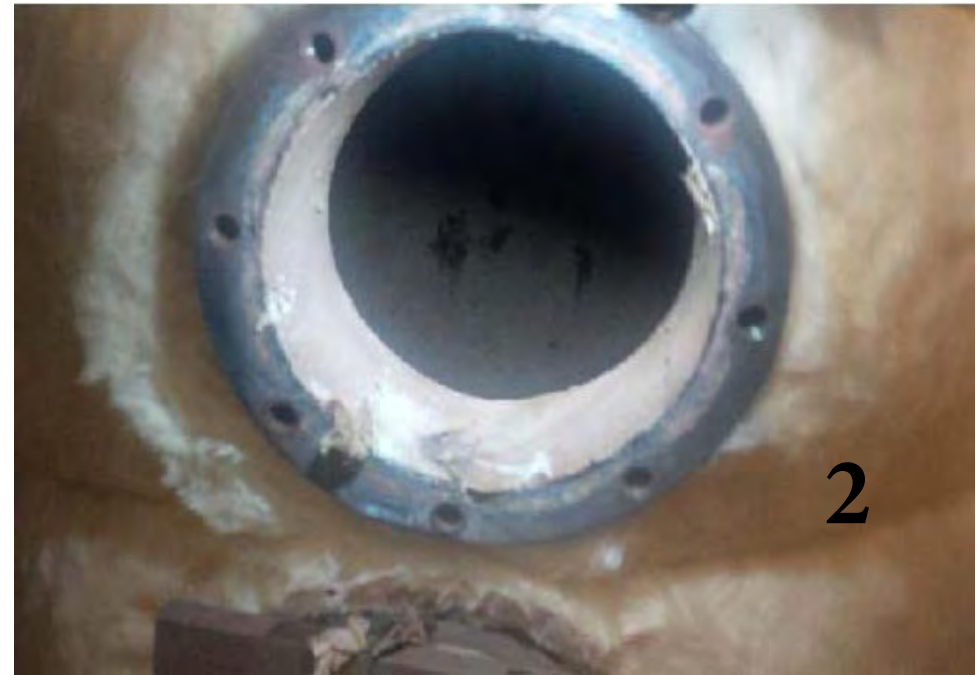
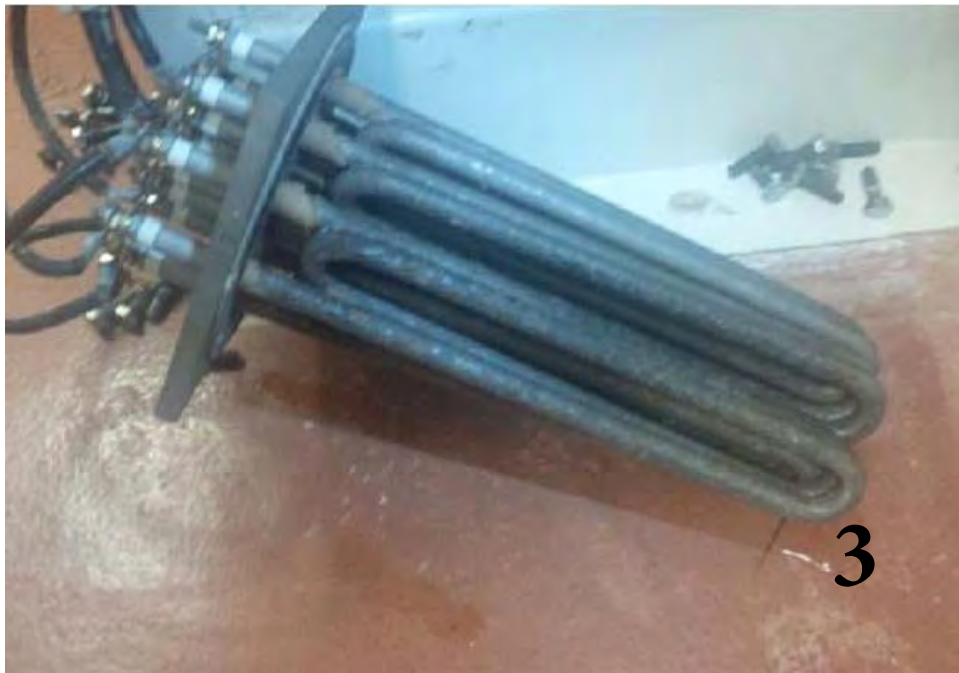
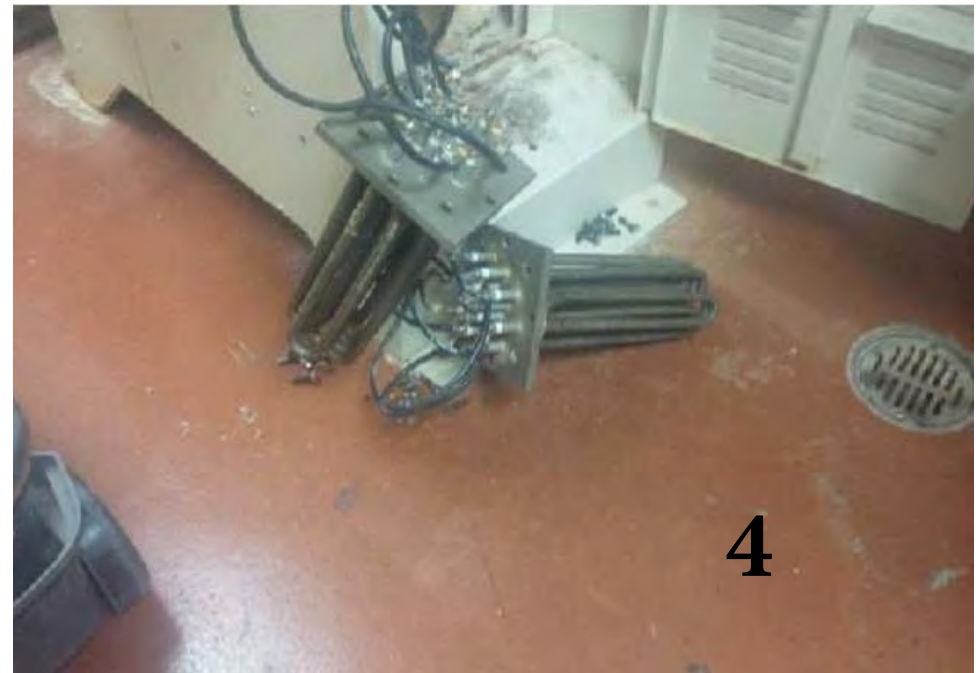
After 6 month with HydroFLOW the Steamer was found to be 100% scale free

Normally these are so full of scale that it would ground itself out and we would have to replace it, but as you can see not a drop of scale. It is unbelievable that it works this good. So your product already paid for itself. Thanks.
