# Heat exchanger Test case

**Effect of HydroFLOW  
on SCALE & CORROSION**

## **REPORT OF AN EXPERIMENT USING HYDROFLOW**

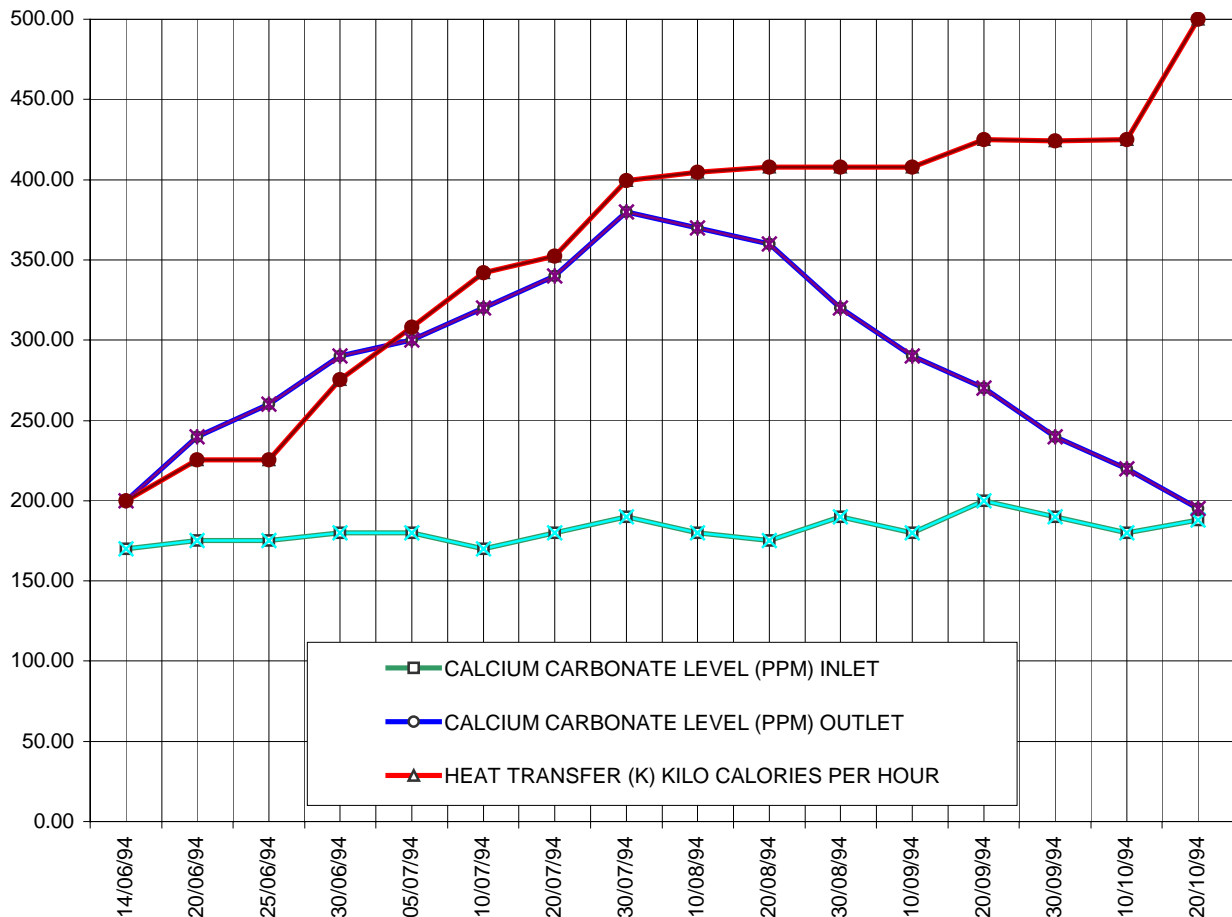
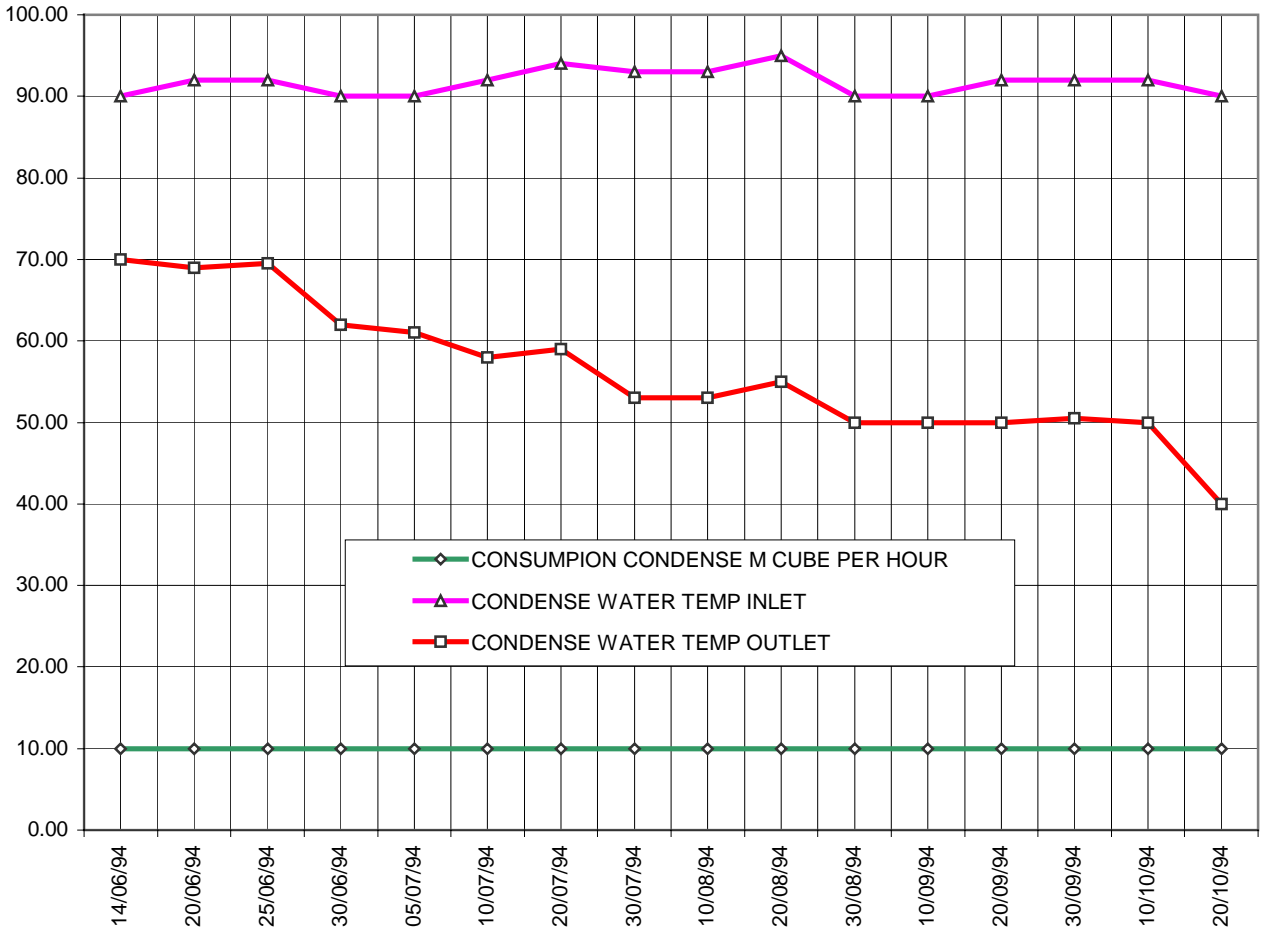
Attached are various tabulations of the results that were supervised and monitored throughout the experiment.

- a. The level of calcium ( $\text{Ca}^{++}$ ) expressed as  $\text{CaCO}_3$  initially increased in the outlet water flow. As the experiment continued this reduced and, towards the end of the experiment, there was a significant decrease down to the same level as the incoming water. This enabled us to determine the quantity of calcium released from the heat exchanger.
- b. In parallel with the reduction of calcium, there was a gradual and consistent increase in the temperature of coefficient between the inlet and the outlet pipes. This indicated a more efficient heat transfer.
- c. A gradual decrease in the pressure drop was observed on the side of the tubes.
